Dawesleigh Restoration

By John Dunn.

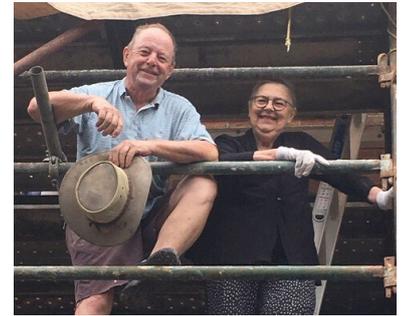
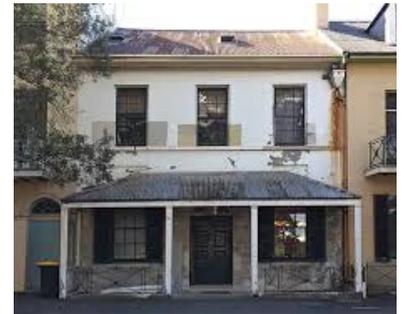
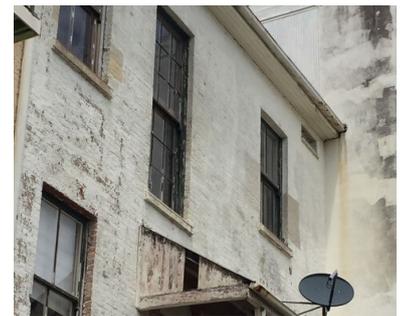
Repointing is now underway and appears to be going well. We remain undecided about the matt clear mineral silicate paint and agree with advice that we should be careful about introducing new materials.

We are not heritage experts, but like others before us, while working on our home we have acquired skills and knowledge about repairing and restoring heritage houses, and we have recorded our progress as we focus on one area after another. Currently we are working outside at the rear of the house where we were preparing to repaint the back wall with breathable mineral silicate paint until discovering it had at been unpainted for a period, with both stone and brickwork being pointed.

Should we repoint instead of painting? If we repoint instead of painting, should we then protect the wall with an application of clear mineral silicate paint? We have an outstanding heritage architect overseeing our works program, but we also wanted to discuss these issues with friends and neighbours before making a decision about what we wanted to do, and we cast around to see what advice was available.
